# NATIONAL TRANSPORTATION SAFETY BOARD

## AIRCRAFT ACCIDENT REPORT

CONTROLLED FLIGHT INTO TERRAIN  
KOREAN AIR FLIGHT 801  
BOEING 747-300, HL7468  
NIMITZ HILL, GUAM  
AUGUST 6, 1997

NTSB/AAR-00/01  
PB00-910401  
Notation 6952B  
Adopted January 13, 2000

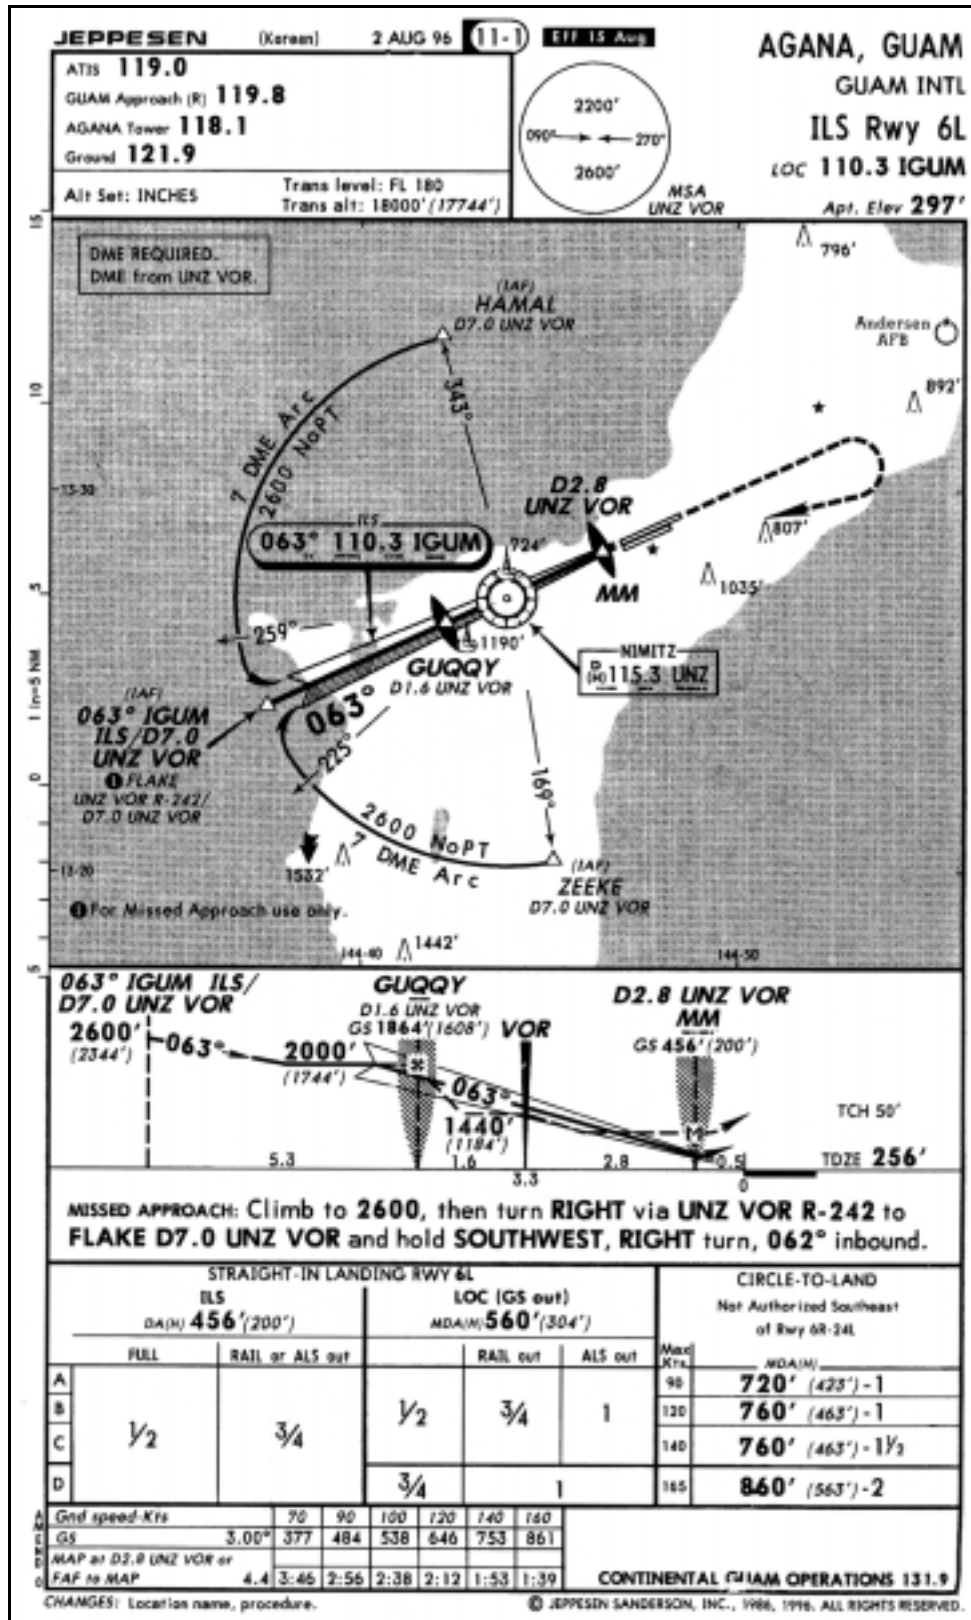
Figure 1. Instrument approach chart for the Guam International Airport runway 6L ILS procedure.

Figure 1 shows the instrument approach chart for the Guam runway 6L ILS procedure that was in effect at the time of the accident. Figures 2 and 3 show FDR information for the last 5 ½ minutes of flight, along with CVR comments and sounds and air traffic control (ATC) data.

The instrument approach charts for Guam International Airport in effect at the time of the accident were issued on August 2, 1996 (with an effective date of August 15, 1996). Changes incorporated in the August 2, 1996, 11-1, ILS runway 6L approach chart (shown in figure 1) included the location names, crossing altitudes, and the missed approach procedure. Table 2 details the specific differences between the January and August 1996 instrument approach charts.
